# Manhole Inspection Summary

Manhole # S15YY\_005MH

Insp Date: **4/6/07 9:17 AM**

**Location** Address: **3438 PARK HEIGHTS AVE**

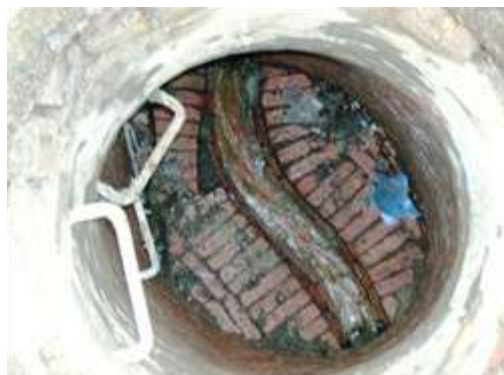
Top View

Corroded steps. Evidence of surcharge - Bench debris.

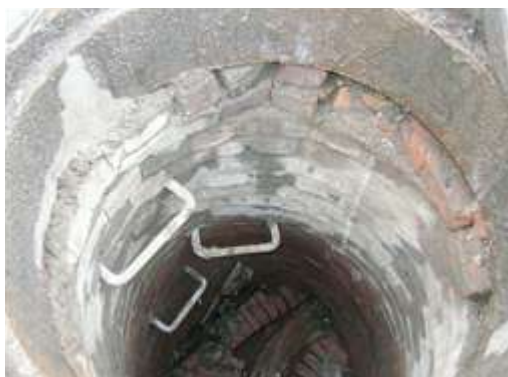
Defect

Frame leaks. Adjustment deterioration, loose brick and infiltration. Corbel and Barrel infiltration - other side.

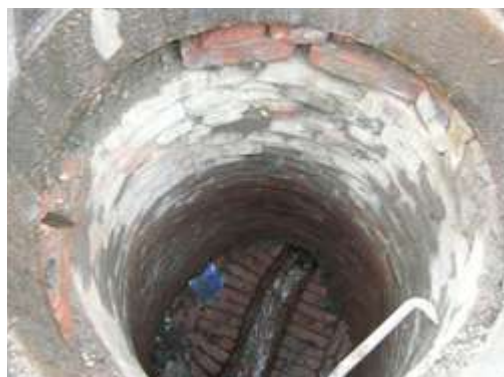
Defect

Frame leaks. Adjustment deterioration, loose brick and infiltration. Corbel and Barrel infiltration.

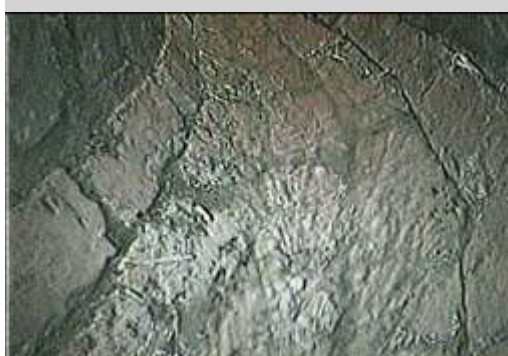
Defect

Channel deterioration

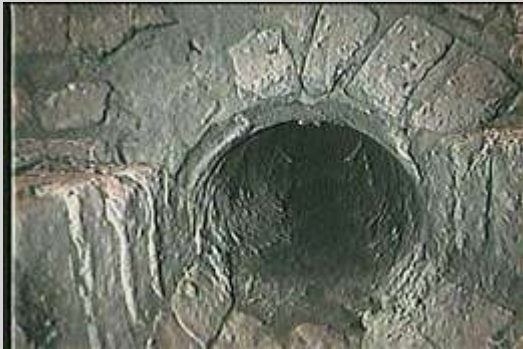
### 8 in. Circular Gravity Sewer Pipe Out @ 12 O'Clock

Deposits: ☐ None ☐ Mud ☐ Sludge ☐ Debris ☒ Grease

Infiltration: **Evidence** Pipe Seal Cond: **Unknown**

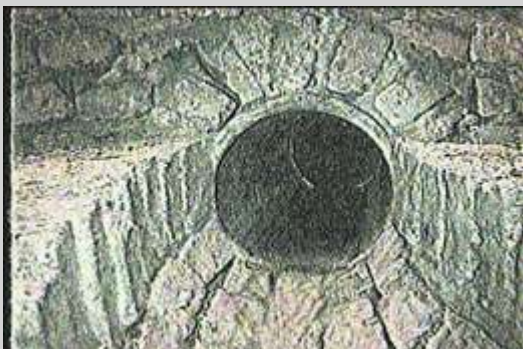
### 8 in. Circular Gravity Sewer Pipe In @ 5 O'Clock

Barrel deterioration and infiltration. Bench and Channel deterioration.
